SEVENTH

CONCRETE PAVEMENT

September 9-13, 2001

CONCRETE PAVEMENTS AT THE MUNICH AIRPORT: DESIGN, CONSTRUCTION AND PERFORMANCE

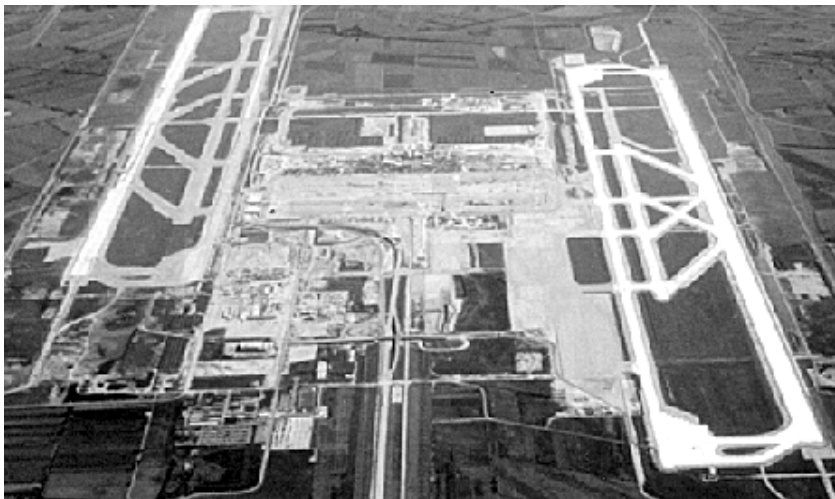
Fig. 1: General view of the Munich airport during construction

A new airport was built at Munich between 1985 and 1992 (Fig. 1). Two 60 m wide and 4,000 m long runways, as well as all taxiways and aprons were given a two-layer, non-reinforced concrete pavement with doweled transverse joints (i. e. jointed plain concrete pavement, JPCP), using the slipform construction technique. The aircraft movement areas in concrete have stood the test of time extremely well. Some 20 million passengers having used the airport in 2000, therefore a second terminal and a second apron are needed. The apron will be constructed also using the "Munich construction method", which has been the model for other German airport, too. The only modification concerns joint filling: Polysulfide-based compounds will replace bituminous joint fillers in the aircraft parking areas – where aircraft are refueled.

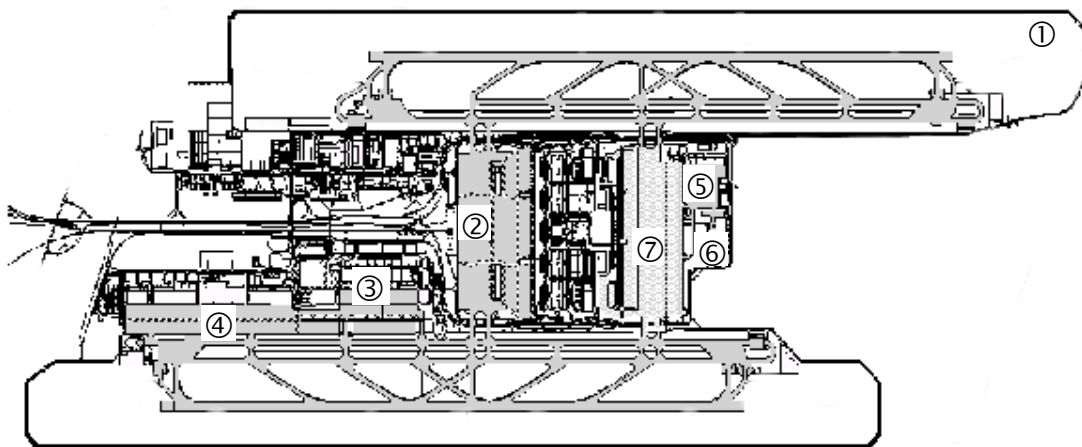
| ① Runway Systems N+S | ⑤ Apron GENERAL AVIATION |
| ② Apron PAX | ⑥ HELIPORT |
| ③ Apron CARGO | ⑦ Apron PAX, Stage 2 |
| ④ Apron MAINTENANCE | |

Fig. 2: Munich airport – general layout

The Phase I aircraft movement areas consisted of two parallel runways, each 4,000 m long and 60 m wide, with the associated taxiway systems and aprons for passenger handling, cargo, maintenance, general aviation and a heliport (Fig. 2) covering a total paved area of approximately three million m², 2.5 million m² of which have concrete pavements [1]. Previous experience has been taken into consideration for the some 400,000 m² large Phase II apron, which is currently under construction.

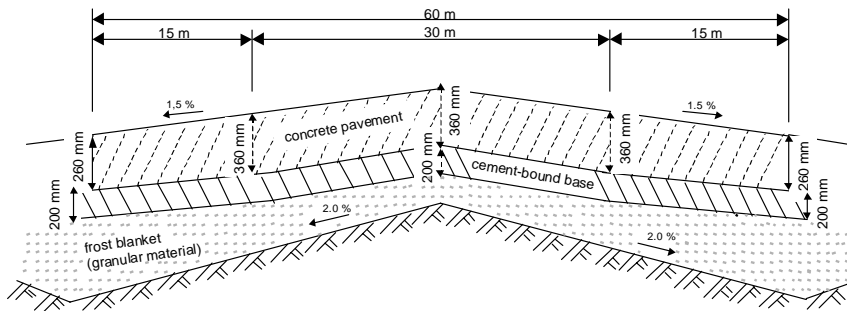
Fig. 3: Typical cross section of the runway of the Munich airport

All aircraft movement areas have been designed for a load-bearing capacity as per PCN 90. The supporting medium was compacted to a maximum (Proctor) density of 103 percent. The degree of compaction was checked over the entire area (i.e. not just spot checks) using the recently developed dynamic compaction test [1]. A cement-bound base, with a minimum 28-day compressive strength of 6 N/mm², was placed between the supporting medium and the concrete pavement. The runway concrete pavements are 360 mm thick in the middle, at the edges 260 mm (Fig. 3), and those of the aprons 400 mm. Besides the traffic loads – quadruple-gear with a maximum wheel load of 4 x 225 kN = 900 kN -, a curling caused by temperature gradients of 0.07 K/mm for 30 hours per year was also taken into account. Since the bending stresses due to changes in temperature are higher the greater the slabs are, the spacing between joints was limited to a maximum of 5 m. Endurance calculation was performed according to Miner's theory and gave maximum bending stresses of 3.76 N/mm² [1,2]. The bond between the cement-bound base and the concrete was not taken into consideration in the calculation. The small spacing between joints results in reduced changes in the joint gap widths.

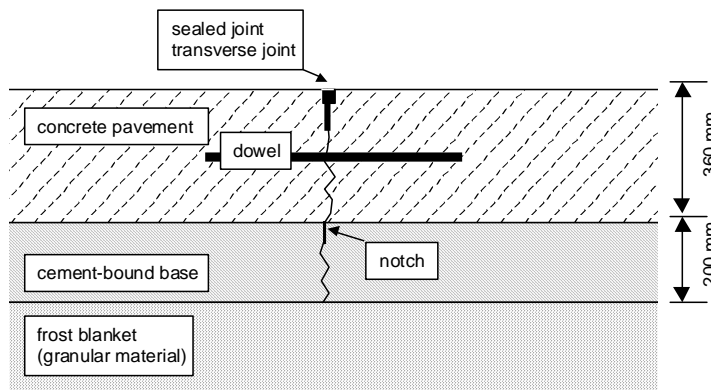
Fig. 4: Sealed, doweled transverse joint in the runway concrete pavement, the cement-bound base is notched underneath the joint

The pavements were placed as jointed plain concrete pavement (JPCP). The dowels in the transverse joints (Fig. 4) and the sinusoidal profile of the longitudinal construction joints (Fig. 5) serve to transmit loads across the joints. The transmission of transverse loads was tested by subjecting sample areas to a wheel load of 15 tons on doweled transverse joints and on longitudinal joints with a sinusoidal profile, as well as on keyway joints. All three construction methods resulted in extremely small vertical movement of approximately 0.06 mm.

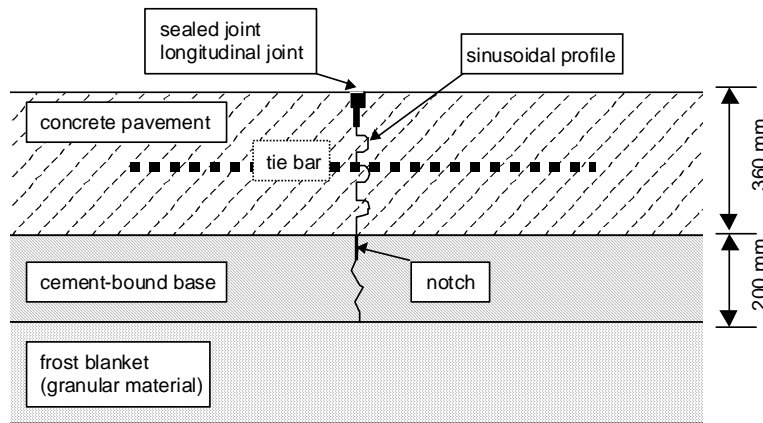
Fig. 5: Sealed, longitudinal joint in the runway concrete pavement, the cement-bound base is notched underneath the joint;

- longitudinal construction joints were constructed with a sinusoidal profile,
- longitudinal contraction joints nearest to the edge were anchored by tie bars

To prevent the joints at the periphery of the concrete pavement from opening, the two longitudinal joints that were nearest to the edge were anchored (Fig. 5). Expansion joints were only provided along different concreting directions of the pavement (for example between the runways and taxiways), next to the slotted gutters on the aprons, and at fittings in the concrete pavement. The joints were cut to a depth of approximately 30 percent of the concrete pavement at the earliest possible time, and subsequently expanded 8 mm at the surface for joint sealing or filling with neoprene sections. An 80 mm deep notch was cut into the cement-bound base underneath all concrete pavement joints when the base was placed (Fig. 4,5), to prevent wild cracks in the cement-bound base and therefore reflective cracks in the concrete pavement.

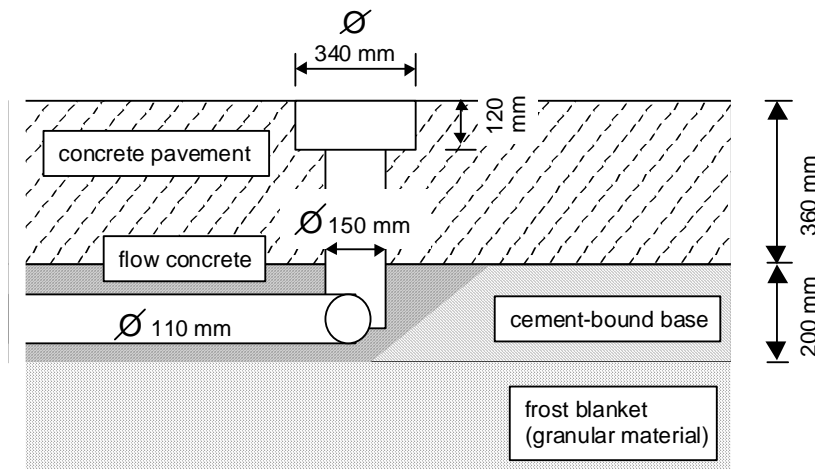
Fig. 6: Conduits for feeder cables for the navigation lights were laid in flow concrete in the cement-bound base; to install the navigation lights holes were drilled through the concrete pavement

The feeder cables for the navigation lights were laid in conduits (diameter 110 mm and 150 mm). For this purpose, the cement-bound base was cut open after hardening using a milling machine, and then refilled with flow concrete after the conduits were laid. Holes were then drilled through the pavement concrete with diamond bits to install the navigation lights (Fig. 6). Thanks to extremely precise measurement, the feeder conduits for almost all 6,000 lights - only ten misses - were struck first time during the drilling operations.

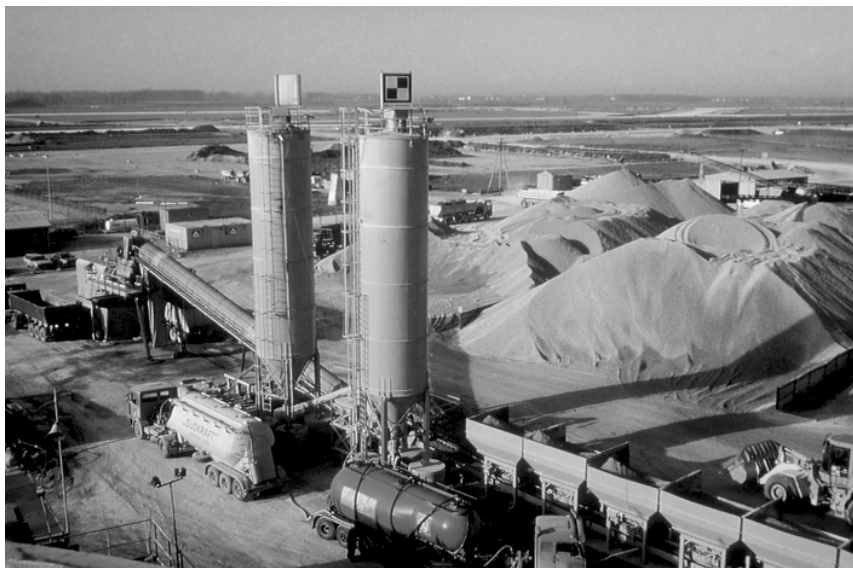
Fig. 7: Continuous mixing plant which can produce up to 220 m³ per hour of high quality concrete; stockpiles of the aggregates in immediate proximity to the mixing plant

The construction period agreed in the contract necessitated an average placement rate of at least 5,000 m² of concrete per day. For this reason, two mixing plants with a capacity of 140 m³ per hour of top concrete and 220 m³ per hour of bottom concrete were set up on the airport site over the entire construction period, allowing the wet-mix volumes required for a placement width of 15 m, a placement thickness of 360 mm and a placement rate of about 1 m per minute to be mixed. In this construction project, continuous mixing plants (Fig. 7) have proven successful where the base materials are fed in a continuous flow through special weigh feeders into the mixer where they are mixed and conveyed to the discharge [4,5]. A comparison with previously used batch mixing plants showed that concrete produced in continuous mixing plants resulted in the same average values and standard deviations in terms of bending tensile strength and air void content as concrete from batch mixing plants [4]. In some cases, the standard deviations were even lower.

To obtain a daily output of 3,000 m³ of wet-mix, around 6,000 tons of aggregates and approximately 1,000 tons of cement had to be delivered to the construction site every day. This corresponds to about 250 truck loads per day. The aggregates were stockpiled on the site in immediate proximity to the mixing plants (Fig. 7). Reliable delivery by rail of the cement to a container terminal in immediate proximity to the construction site meant that for the two mixing plants four silos with a capacity of 100 tons each were sufficient for storage.

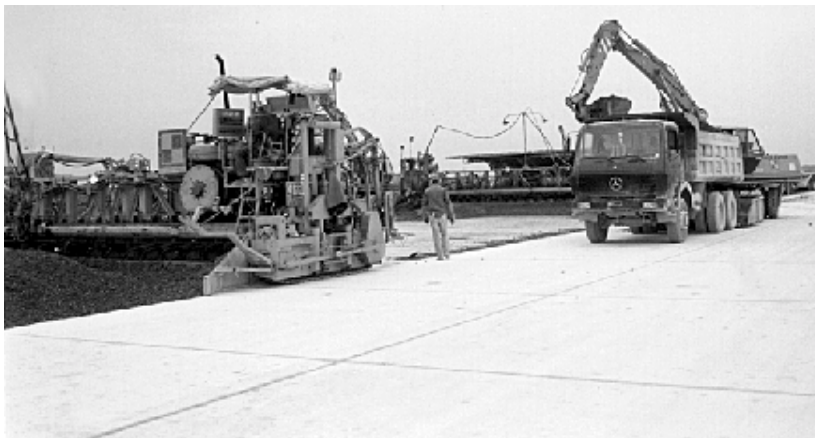
Fig. 8: Construction of the concrete pavement of the runway in two layers with a special slipform paving train consisting of two slipform pavers; here unloading the top concrete from trucks and spreading in front of the second paver by an excavator

The two-layer concrete pavement was placed by two separately operated slipform pavers (width up to 15 m, Fig. 8) that were specially designed and built for construction projects of this type [3,5,6], great importance being placed on rapid setting-up and dismantling without the need for self-propelled cranes, and on easy transfer to conventional flat-bed trucks with a road permit.

The bottom concrete was dumped by trucks in front of the bottom concrete paver (Fig. 8,9) on the cleaned and wetted cement-bound base, spread across the base, placed to the required thickness and compacted by internal vibrators. The dowels and tie bars were vibrated into the compacted bottom layer by the bottom concrete paver.

Immediately following this, the top concrete was unloaded from trucks by excavators on both sides of the strip to be placed and spread evenly in front of the top concrete paver on the compacted bottom layer (Fig. 8-10). The top concrete paver placed the top concrete wet-in-wet at the specified thickness and elevation on the bottom layer, after which the concrete was again compacted by internal vibrators. The top concrete paver then smoothed the concrete surface lengthwise and crosswise. In order to obtain the required skidding resistance from the start, the wet concrete surface was broom finished crosswise by a self-propelled working platform. Height and directional control of the entire paving train was effected electronically by means of guidewires.

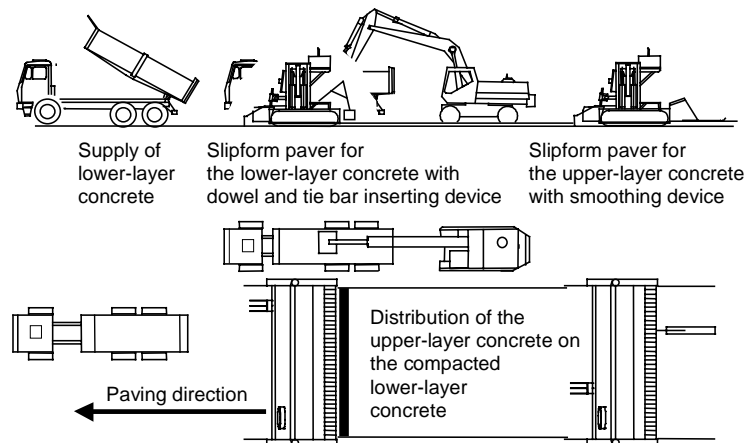
Fig. 9: Slipform paving train consisting of two slipform pavers for construction of concrete pavements in two layers; the concrete for the top layer is placed in front of the second paver by an excavator from the side

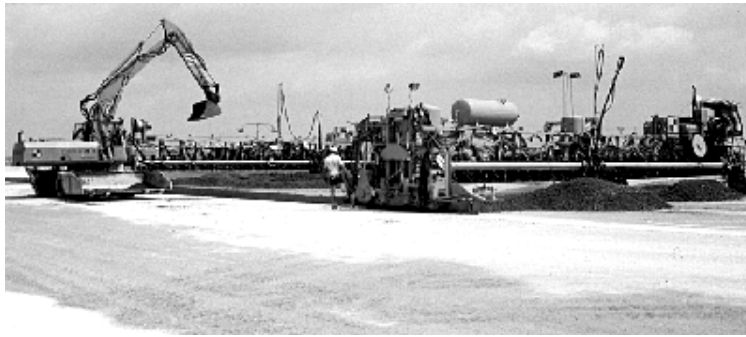
Fig. 10: Construction of the concrete pavement for the runway in two layers in slipform technology, placement width 15 m; here construction of the first strip as a “pilot strip” with sinusoidal longitudinal construction joints (see Fig. 5)

The quality and cost-effectiveness of the construction work were raised by firstly constructing every second strip as a "pilot strip" and placement width 15 m with the aid of slipform technology (Fig. 10,12). The intermediate strips were then placed without the need for any side formwork. The longitudinal compression joints were formed by means of sinusoidal formwork (Fig 5,12). Smooth formwork was only used at the sides. The special slipform pavers (Fig. 8-11) deployed for two-layer, 15 m wide placement in slipforms [3,5,6] enabled placement rates of 10,000 m² of aircraft movement areas per day, meaning approximately 3,600 m³ of concrete. Even oblique-angled connections of high speed exit taxiways or taxiway intersections with vertical curve radii of 30 m were constructed exclusively with the aid these slipform pavers, allowing the number of slabs constructed without pavers to be minimized.

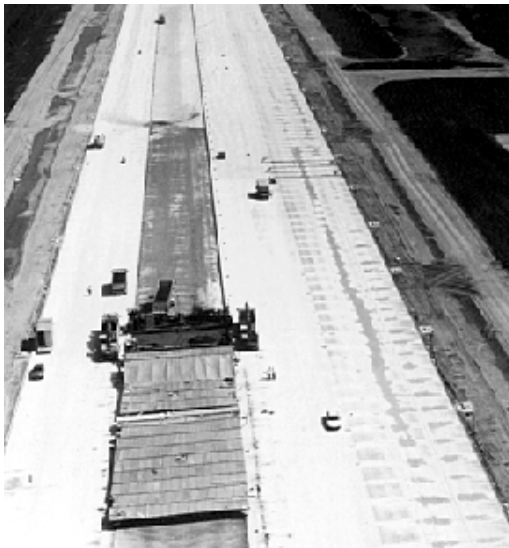
Fig. 11: Construction of the concrete pavement for the runway in two layers in slipform technology; tents were only dragged behind the paving train during the first days of concrete placement

Curing was carried out in two steps: First, a liquid curing compound was automatically sprayed from the working platform onto the wet concrete surface. At high temperatures, low humidity and high wind velocities, the Client requested that water be sprayed on additionally which was paid separately. Spraying on water prevented the top concrete from excessive heating due to solar radiation, that would otherwise have caused high temperature stresses [7]. During the first days of concrete placement, tents were dragged behind the paving train (Fig. 11). After this, the tents were no longer used; instead, the concrete placement was suspended sufficiently in advance of rainfall [1].

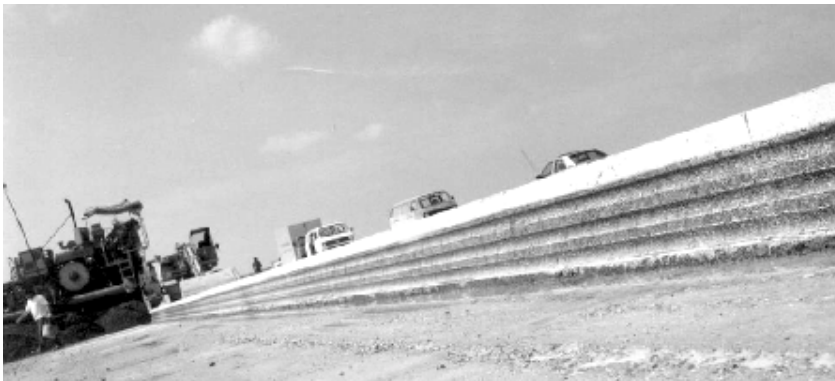
Fig. 12: Longitudinal construction joint of a "pilot strip" with sinusoidal profile, constructed with a slipform paving train, placement width 15 m

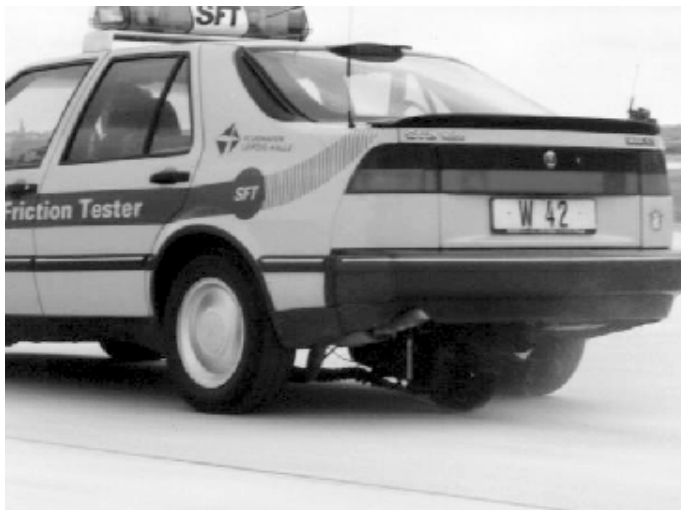
Fig. 13: The concrete pavement for the aircraft movement areas of the Munich airport still provides good skidding resistance; Saab Friction Testers are used for testing the skidding resistance of aircraft movement areas in Germany

- Good skidding resistance over time (Fig. 13);
- Highly uniform level with deviations far below the tolerance limit (determined by measurements using the high-speed road monitoring system);
- High resistance of the concrete to deformation (no ruts or lateral displacements in aircraft parking aprons);
- Bright color of the concrete surface; important especially at night and in adverse weather conditions or poor visibility;
- No problems have been encountered so far with regard to brake reaction and aquaplaning.
